Wetland and Waters of the United States Delineation Report

Diamond Tail Solar
Northwest of Golden, New Mexico

Terracon Project No. 66227139

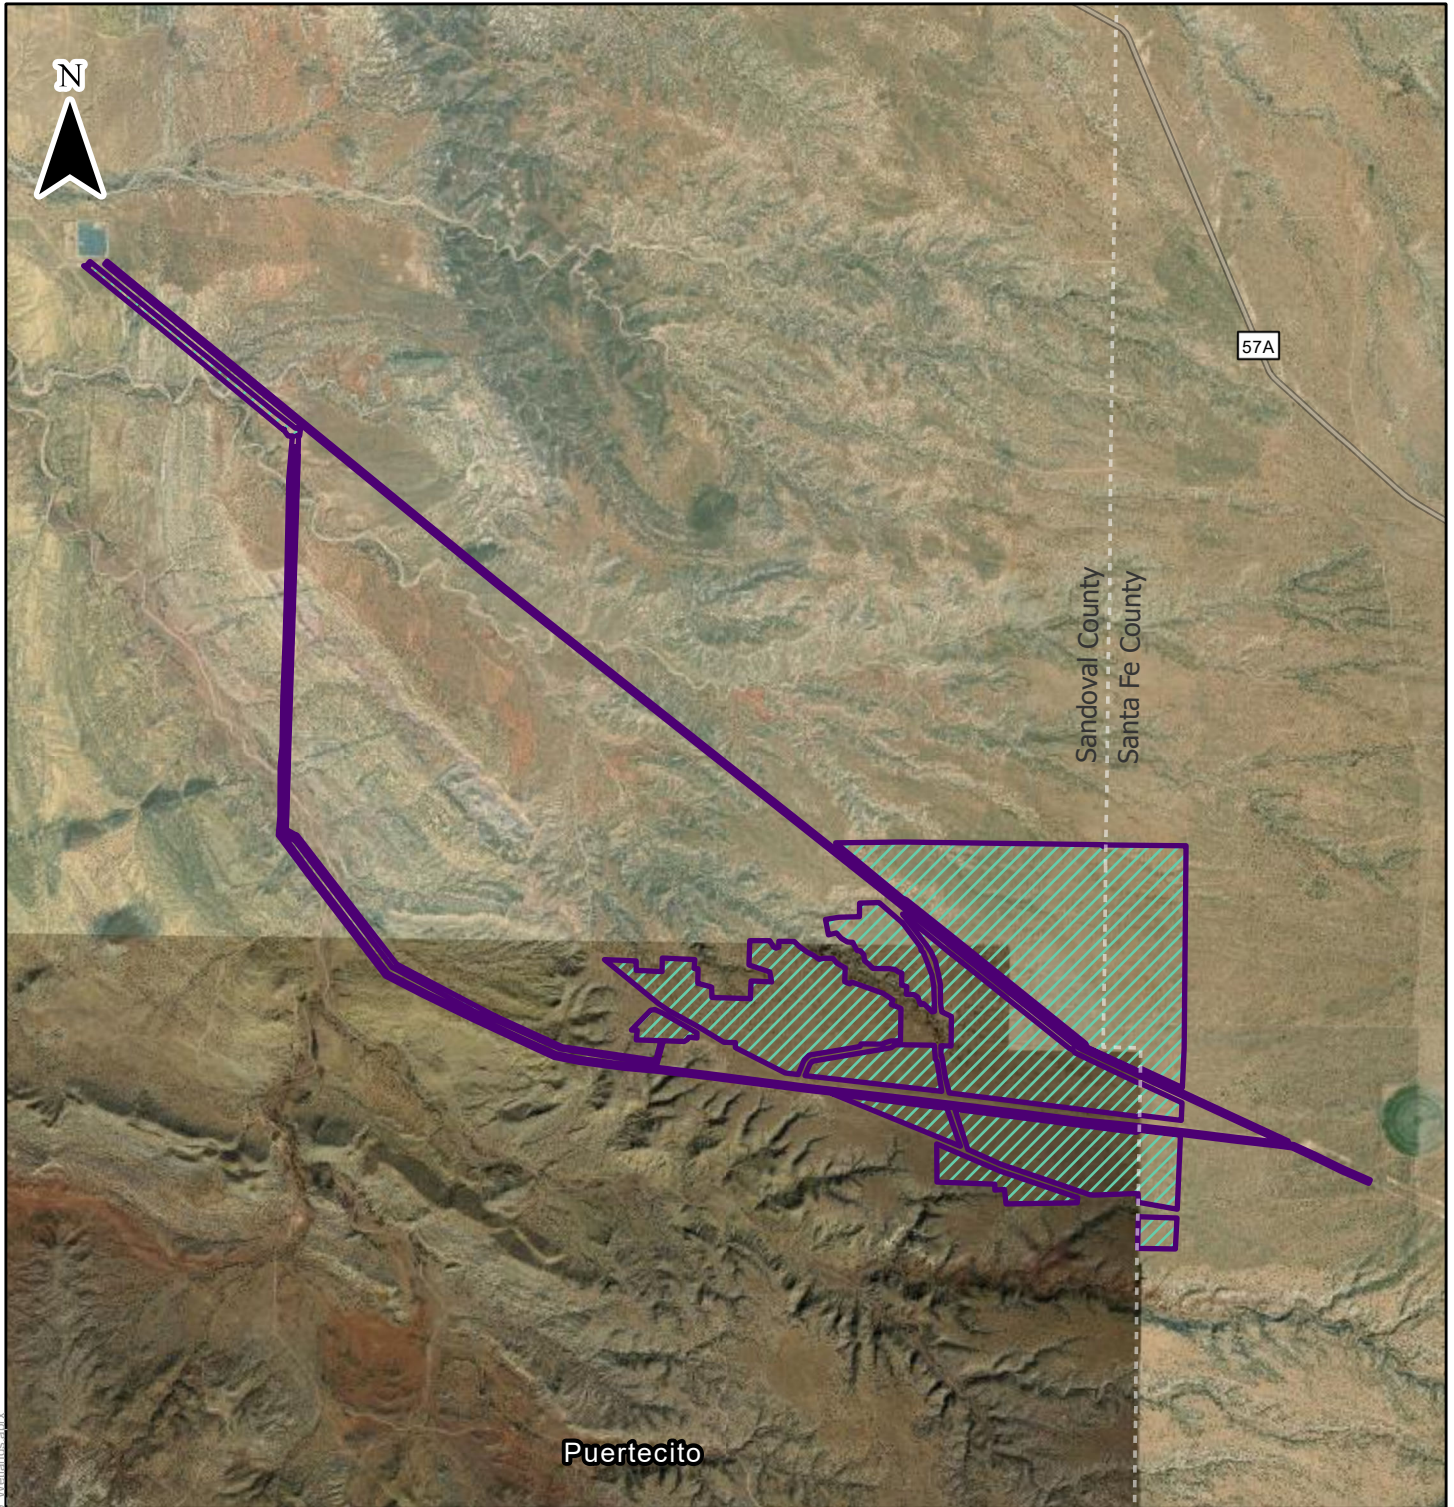
Exhibit 2

Aerial Imagery

A recent aerial image of the project site was reviewed to determine land use and evaluate vegetative cover. Based on aerial photography, the project site currently consists of undeveloped juniper forests with southwest desert landscape near Arroyo Una de Gato (identified as IT 1 and 2) and Arroyo Coyote (identified as IT 3 and 4), both arroyos traverse portions of the transmission line corridor (Appendix A, Figure 2).

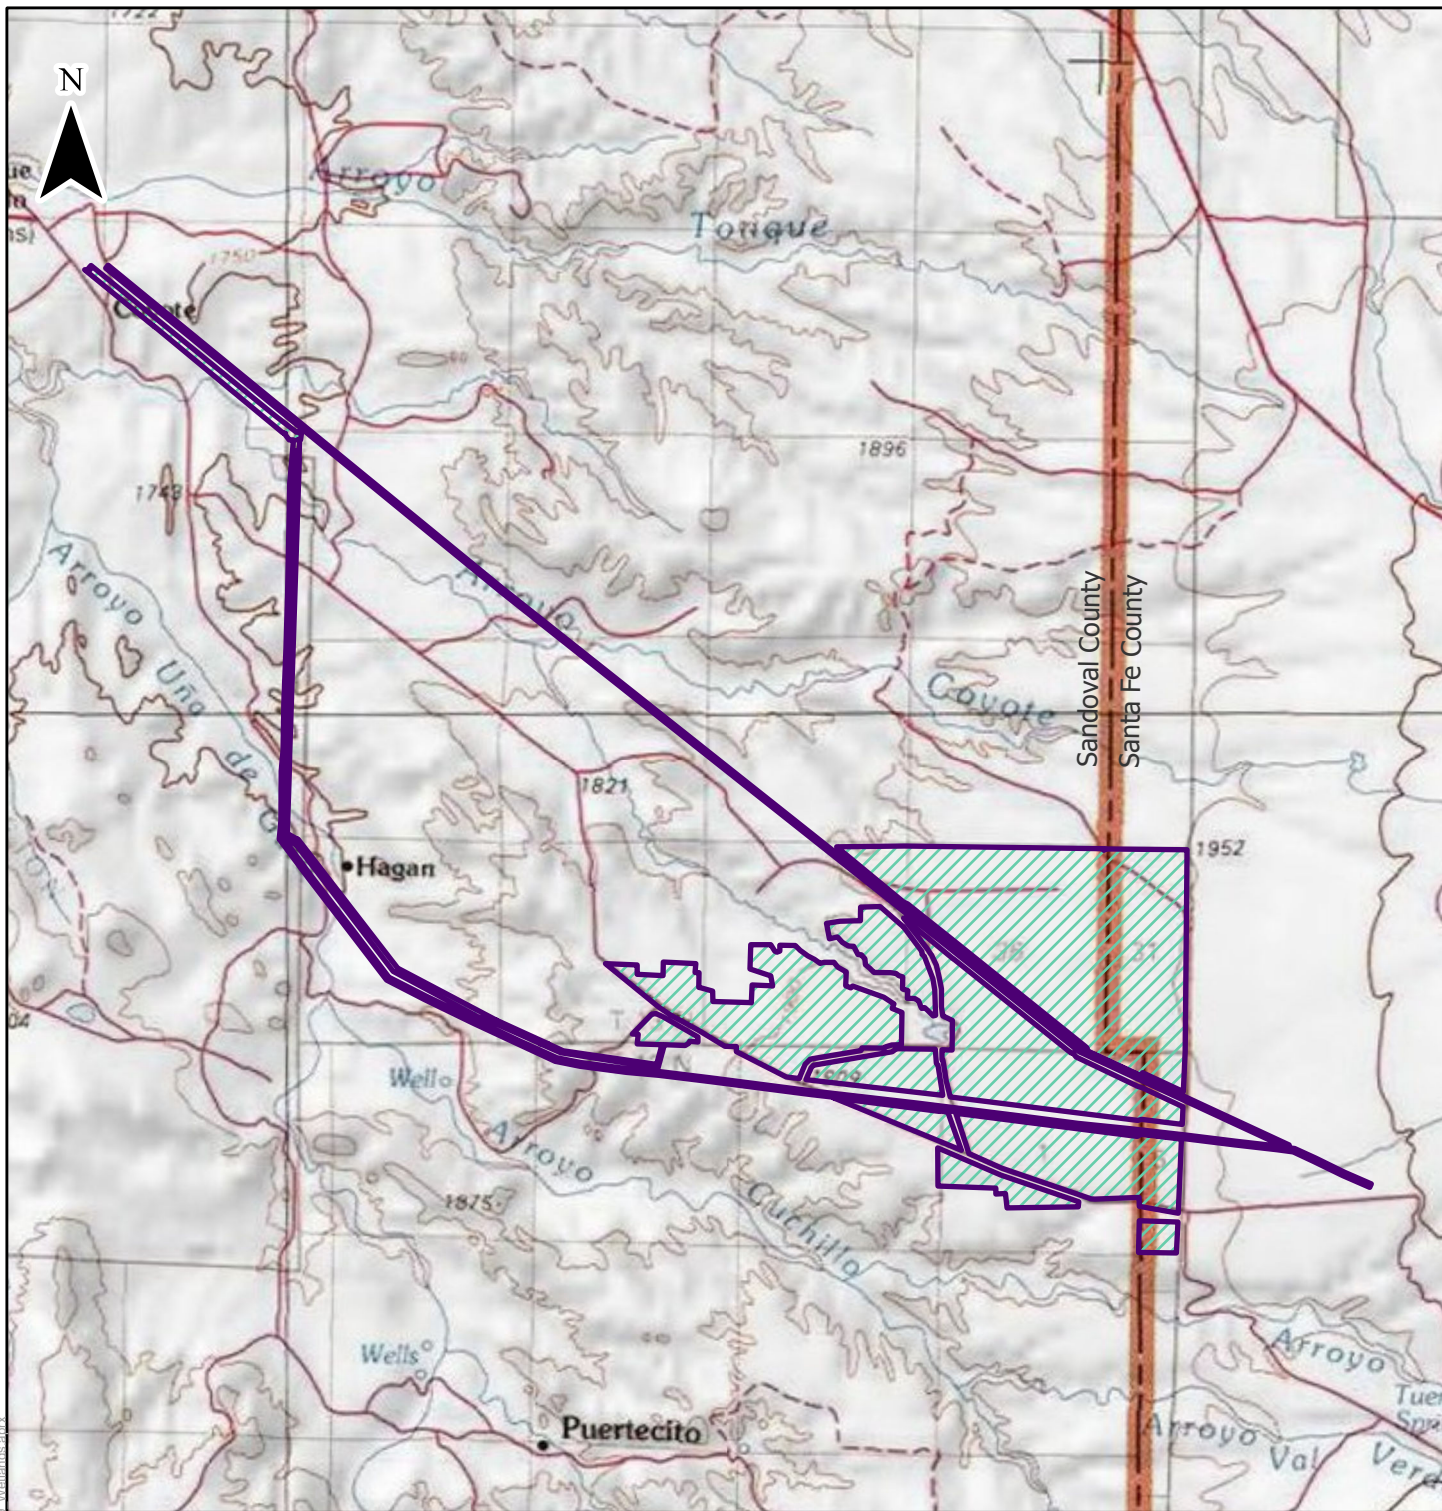
Exhibit 3

USGS Topographic Map

United States Geological Survey (USGS) Golden quadrangle topographic map was reviewed to assess topographical features of the Project Site. The Site has an elevational range of approximately 6,200 to 6,360 feet above sea level. The proposed solar panel pads are located at the top of a mesa whereas the transmission line corridor traverses over several rolling hills before meeting up with the substation to the northwest (Appendix A, Figure 3).

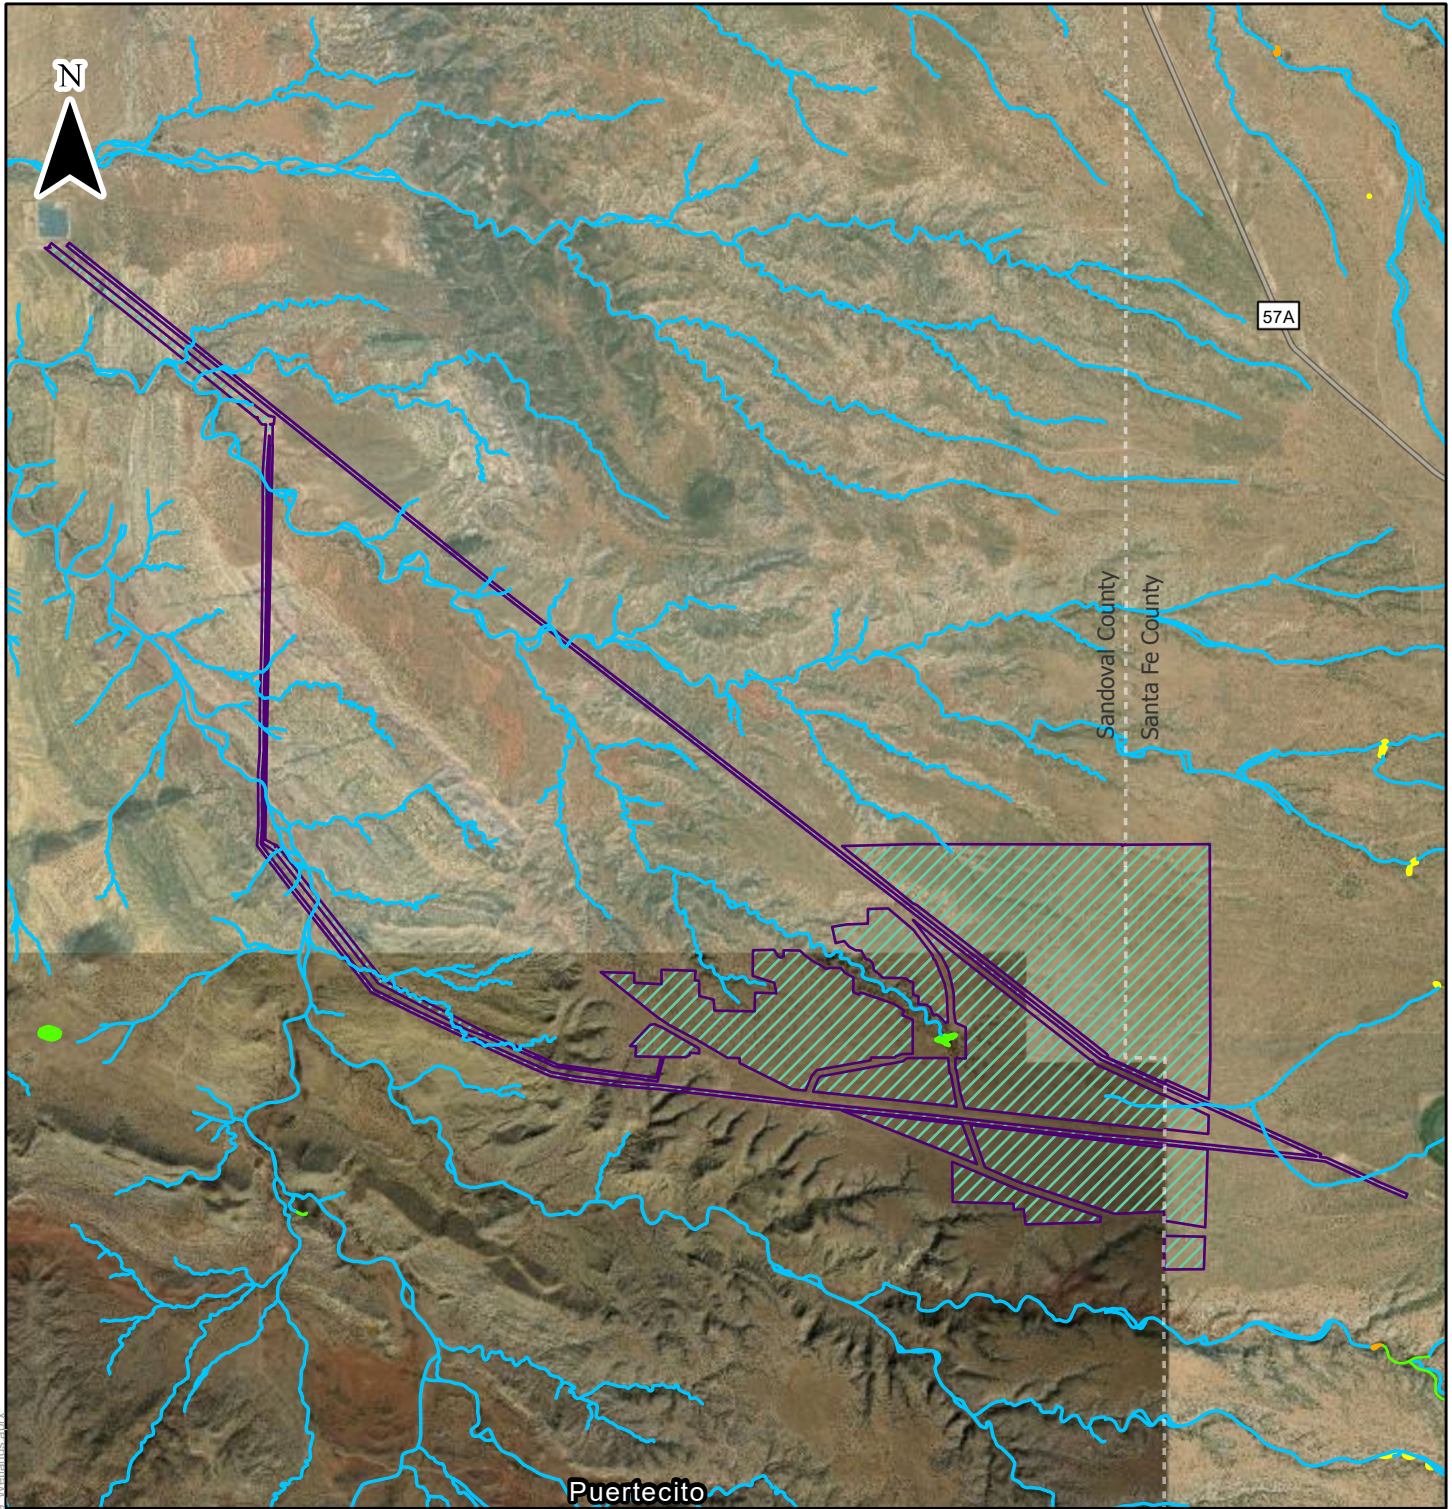
Exhibit 4

National Wetland Inventory

stereoscopic analysis of high-altitude aerial photographs and analysis of infrared bands from remotely sensed imagery (Appendix A, Figure 4). A total of 13 aquatic features that were found within the project area according to the NWI map. A list of the types of features and their quantities can be found below (Table 1).

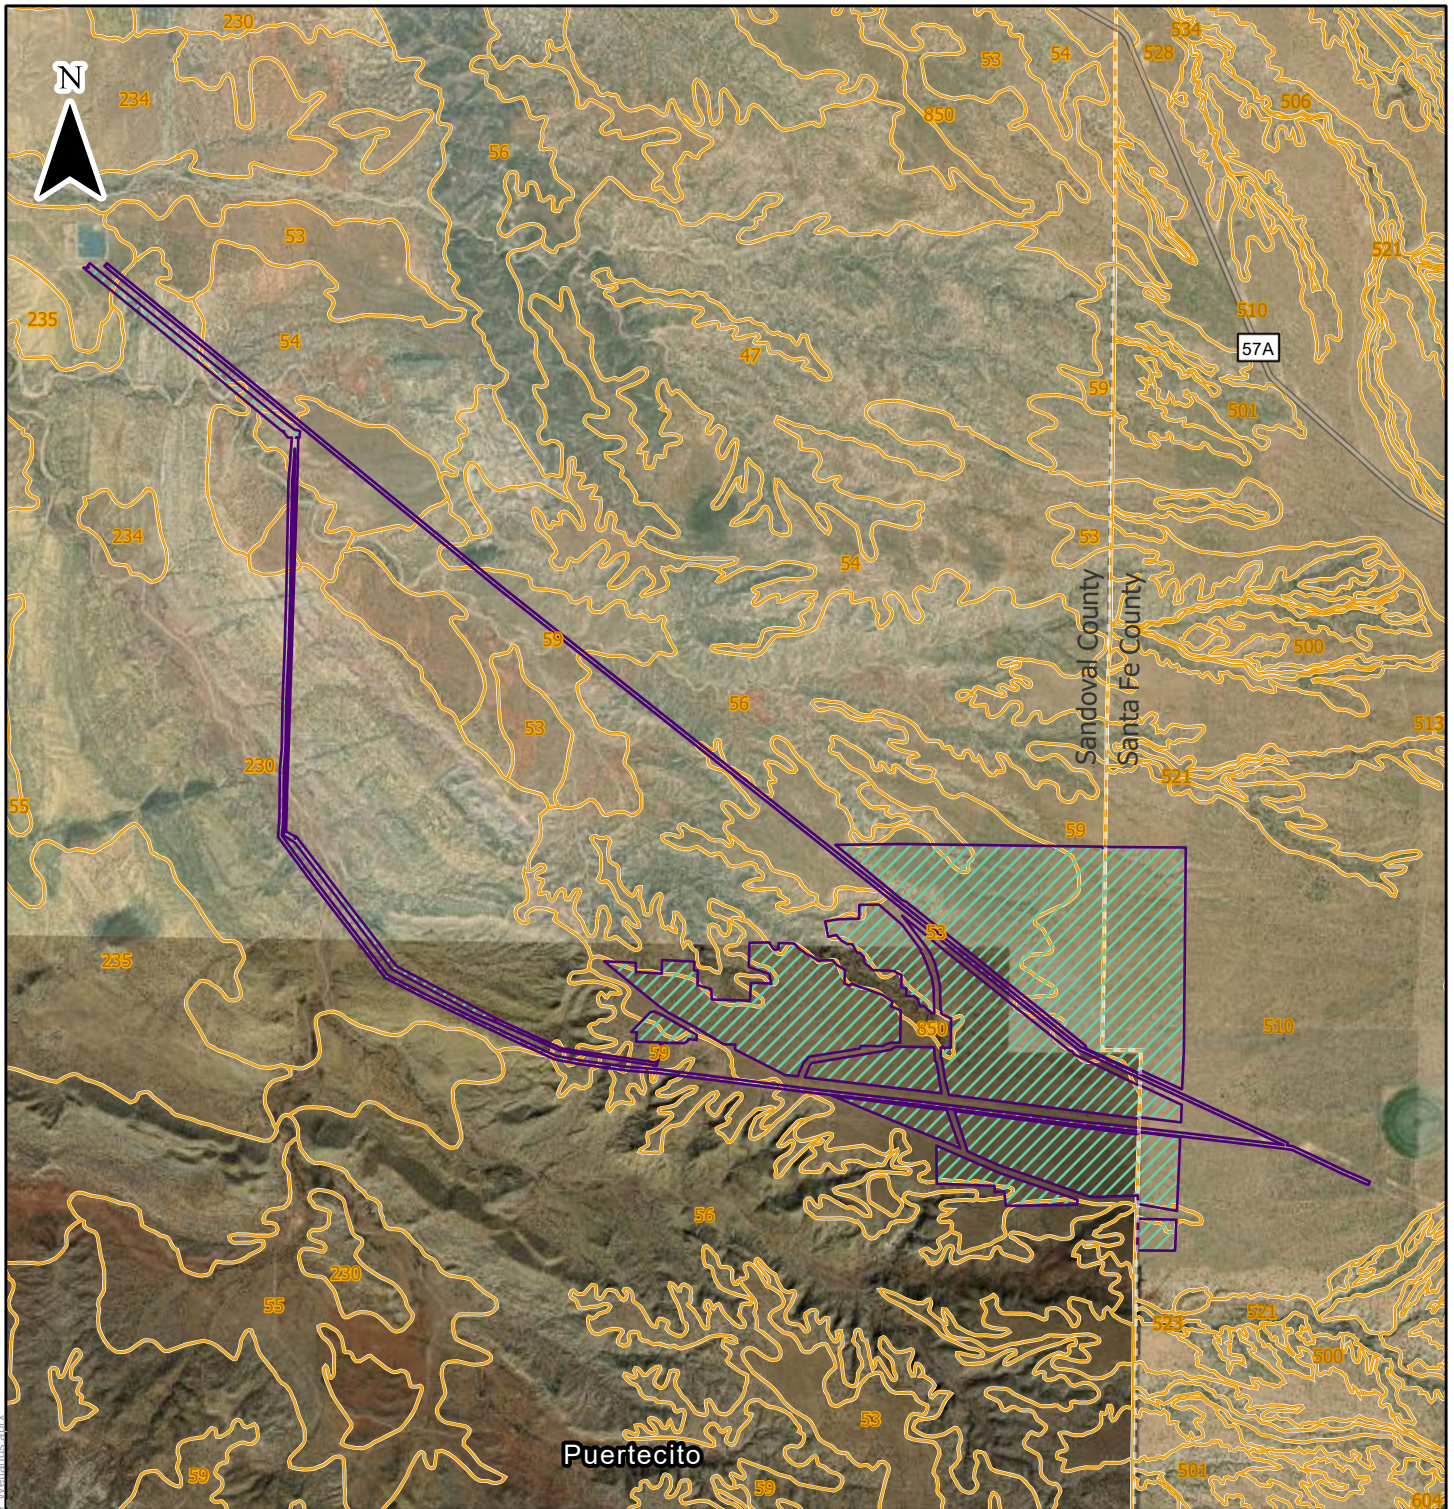
Exhibit 5

USDA Soil
Diamond Tail
Sandoval County, New Mexico
Prepared for Conifer Power Company

Data from the United States Department of Agriculture (USDA), Natural Resource Conservation Service (NRCS) soil survey for Sandoval and Santa Fe Counties, New Mexico was reviewed to identify the soil types and groups present within the project area. Soil groups help identify what soils have a higher potential runoff and are split into four groups: A, B, C, and D (Appendix A, Figure 5). Group A has a lower runoff potential and therefore are more hydric soils and Group D has highest runoff potential indicating a dryer soil. A total of 10 soil types were identified within the project boundary; no hydric soils were identified.

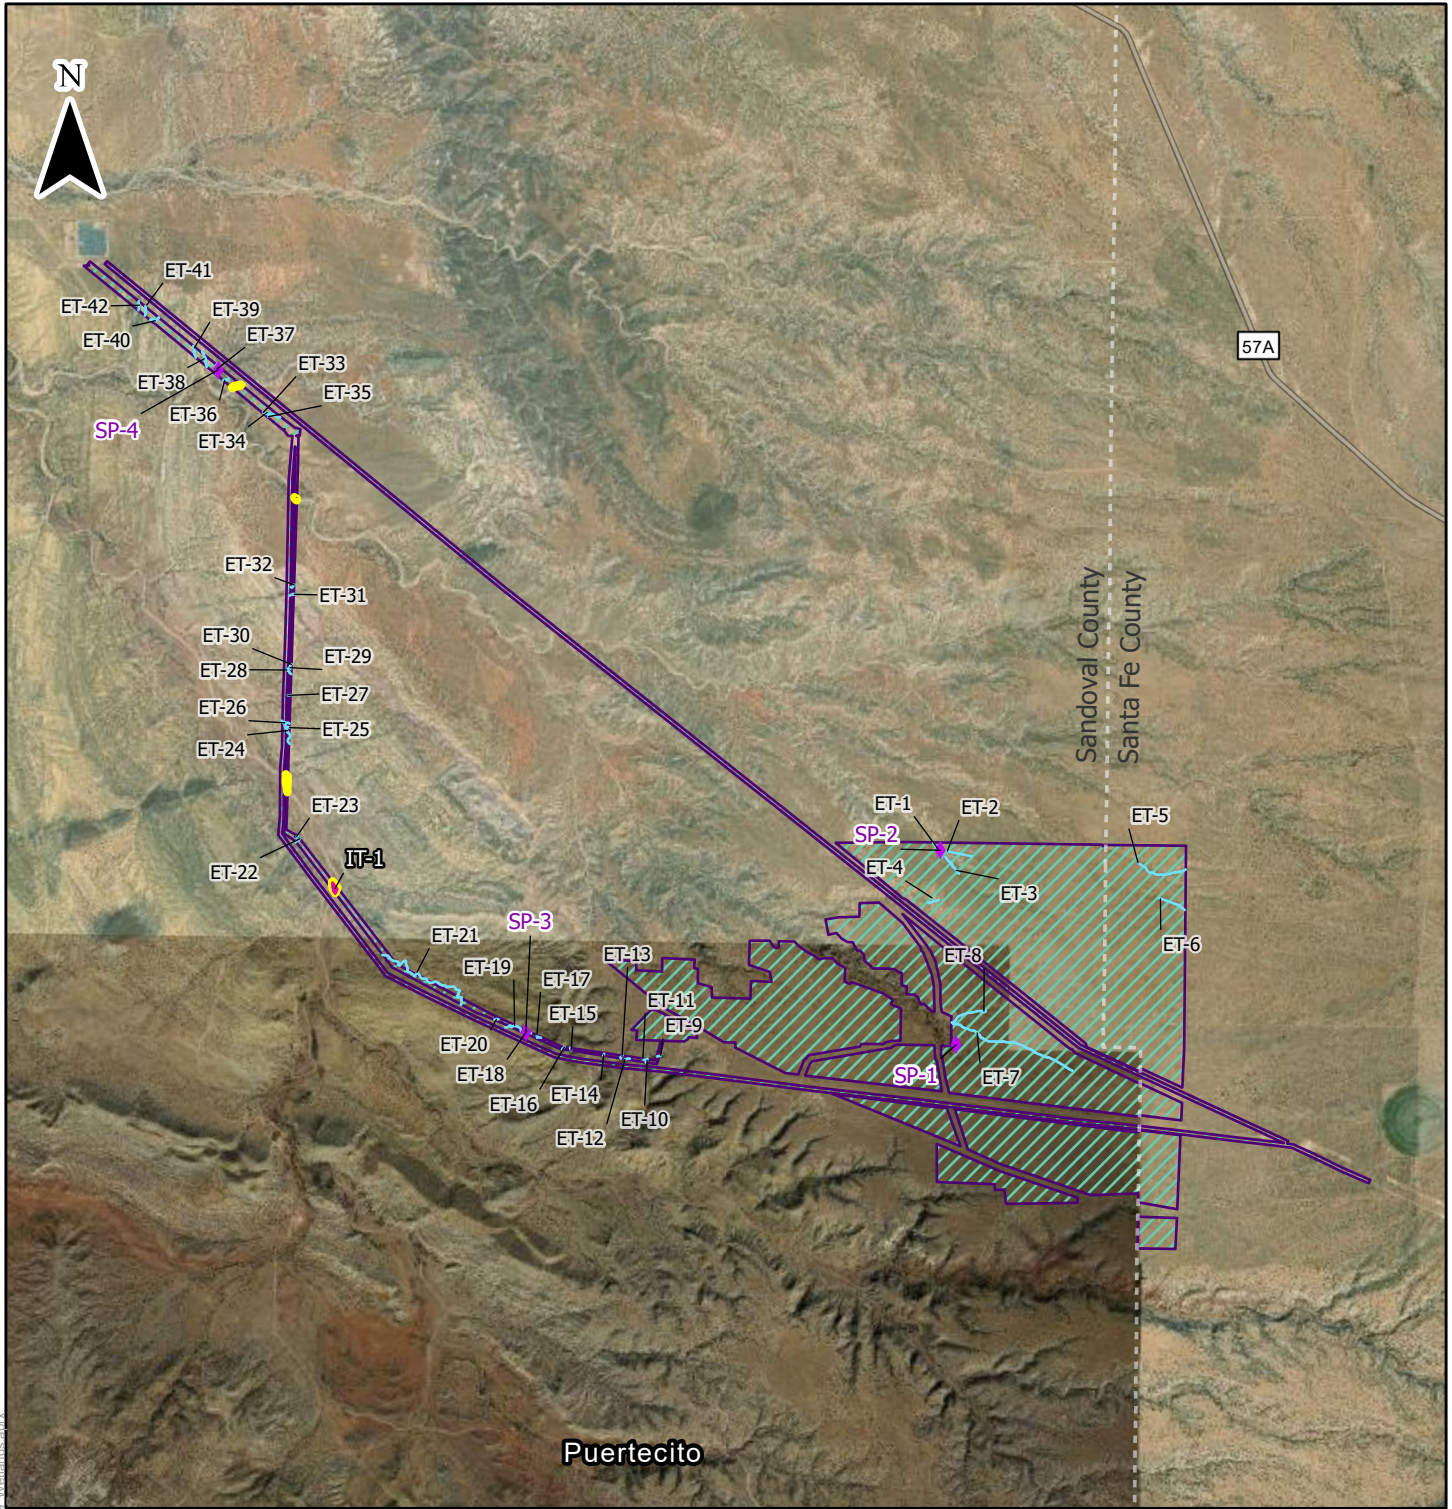
Exhibit 6

Field Data

A total of ±14.64 acres of ephemeral and intermittent tributaries were mapped within the project area (Appendix D). Two arroyo intermittent tributary are located within the site. The Arroyo Una de Gato (IT-1 and IT-2) traverses the southern portion of the transmission line corridor while the other intermittent tributary, Arroyo Coyote (IT-3 and IT-4) traverses the northern portion of the transmission line corridor; both total approximately 8,381.79 linear feet. A total of 42 ephemeral tributaries (ET) were mapped within the project area and transmission line corridor. All of the ephemeral tributaries mapped inside the transmission line corridor had ordinary high water marks (OHWM) with established bed and bank along with all the ephemeral tributaries inside the proposed solar array area except for ET-4, 5, and 6. During the field visit all of these ephemeral tributaries had evidence of recent hydrology in the form of sediment and drift deposits due to a large scale rain event the week both. These ephemeral tributaries within the transmission line corridor and on the west side of the project area flow into the two intermittent arroyos. In total, approximately 46,299.9 linear feet of ephemeral tributaries were documented within the project area and a table with the information for these features can be found in Appendix D. Based on its connection to the Arroyo Una de Gato and Arroyo Coyote, it is Terracon's opinion that the intermittent arroyos and ephemeral tributaries with connection to the intermittent arroyos, excluding tributaries ET-4, 5, and 6, will likely to be considered jurisdictional by USACE.

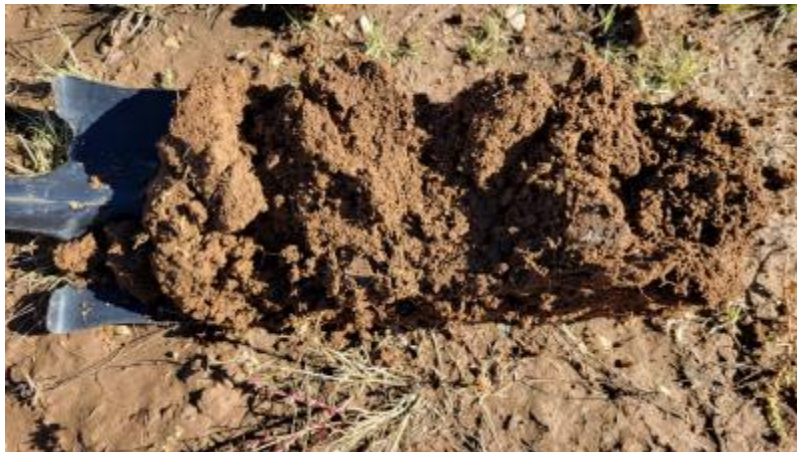
DP1-Soil

Depth (inches)	Matrix		Redox Features				Texture	Remarks
	Color (moist)	%	Color (moist)	%	Type ¹	Loc ²		
0-16	10 YR 3/3	100	-	-	-	-	lm

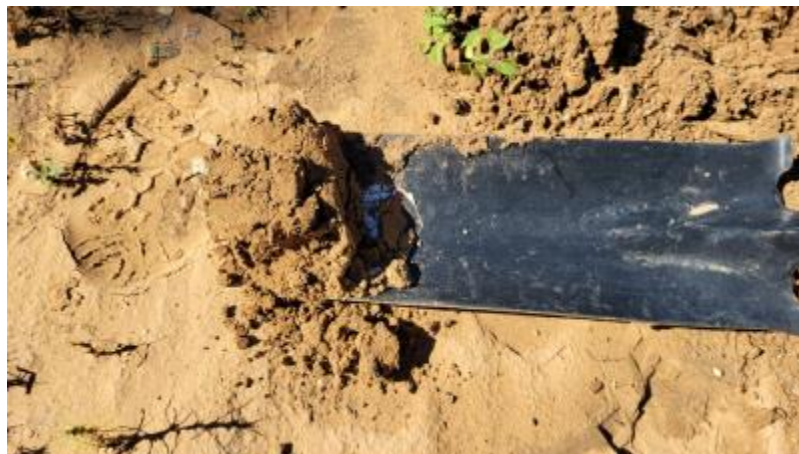
DP2-Soil

Depth (inches)	Matrix		Redox Features				Texture	Remarks
	Color (moist)	%	Color (moist)	%	Type ¹	Loc ²		
0-4	7.5 YR 4/4	100	-	-	-	-	sandy lm

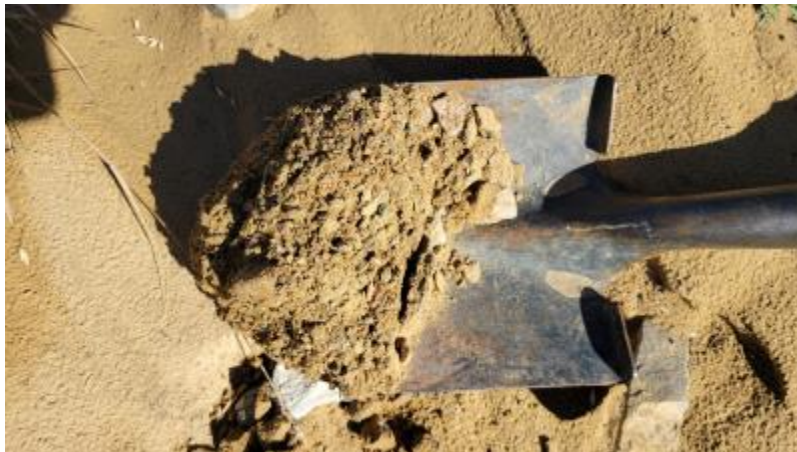
DP3-Soil

Depth (inches)	Matrix		Redox Features				Texture	Remarks
	Color (moist)	%	Color (moist)	%	Type ¹	Loc ²		
0-6	Sand

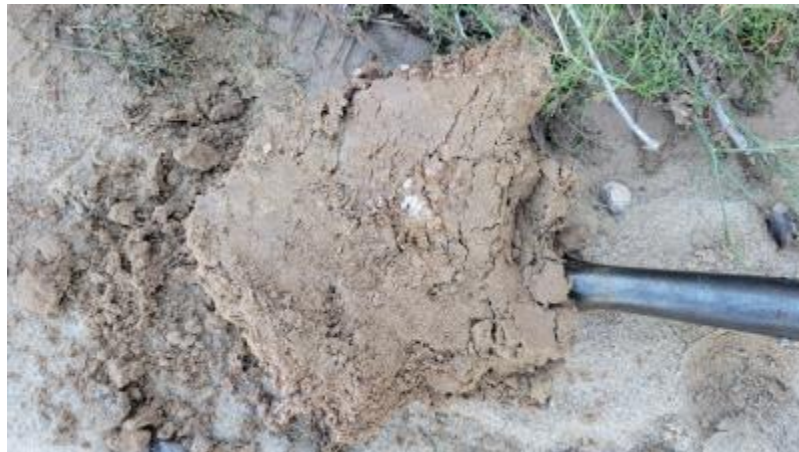
DP4-Soil

Depth (inches)	Matrix		Redox Features				Texture	Remarks
	Color (moist)	%	Color (moist)	%	Type ¹	Loc ²		
0-10	10YR 4/4	100	-	-	-	-	Clayey lm
